New York State Department of Transportation

Yellow Flag NB2258W002

BIN: 1065318

Location: Span 142, Stringer S2 at Pier 142 over 3rd Avenue Eastbound.

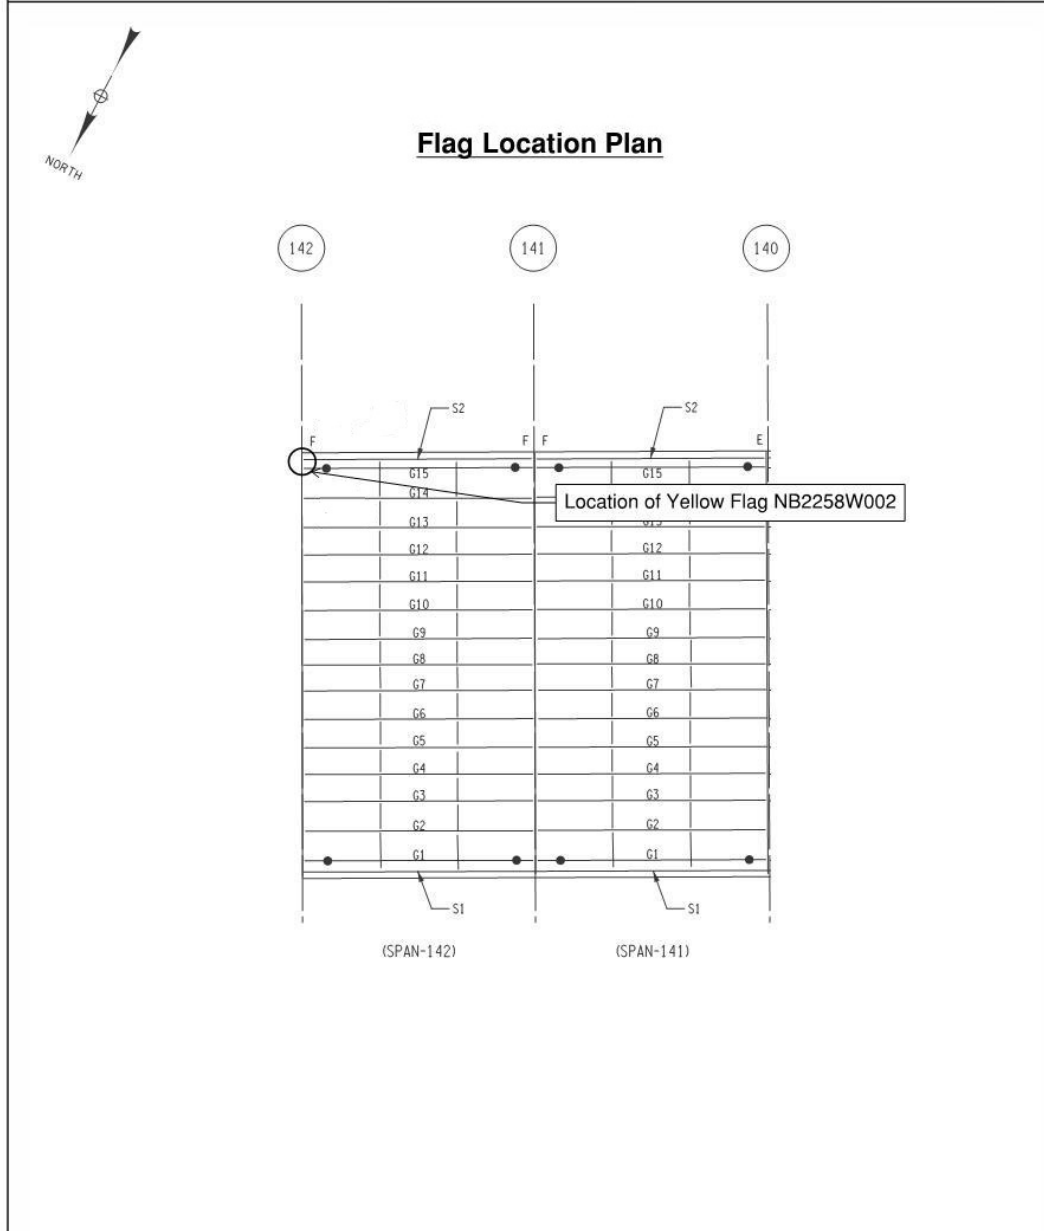
Flag PhotographsPhoto Number: **1**Photo Filename: **22_Flag Location Plan.jpg**Gowanus Expressway
2022 Biennial Inspection - Field SketchBIN: 1065318Team: AA/TSDate: 06/10/2022Span: 142Location: Stringer S2 at Pier 142

**wsp****Attachment Description: Flag Location Plan**

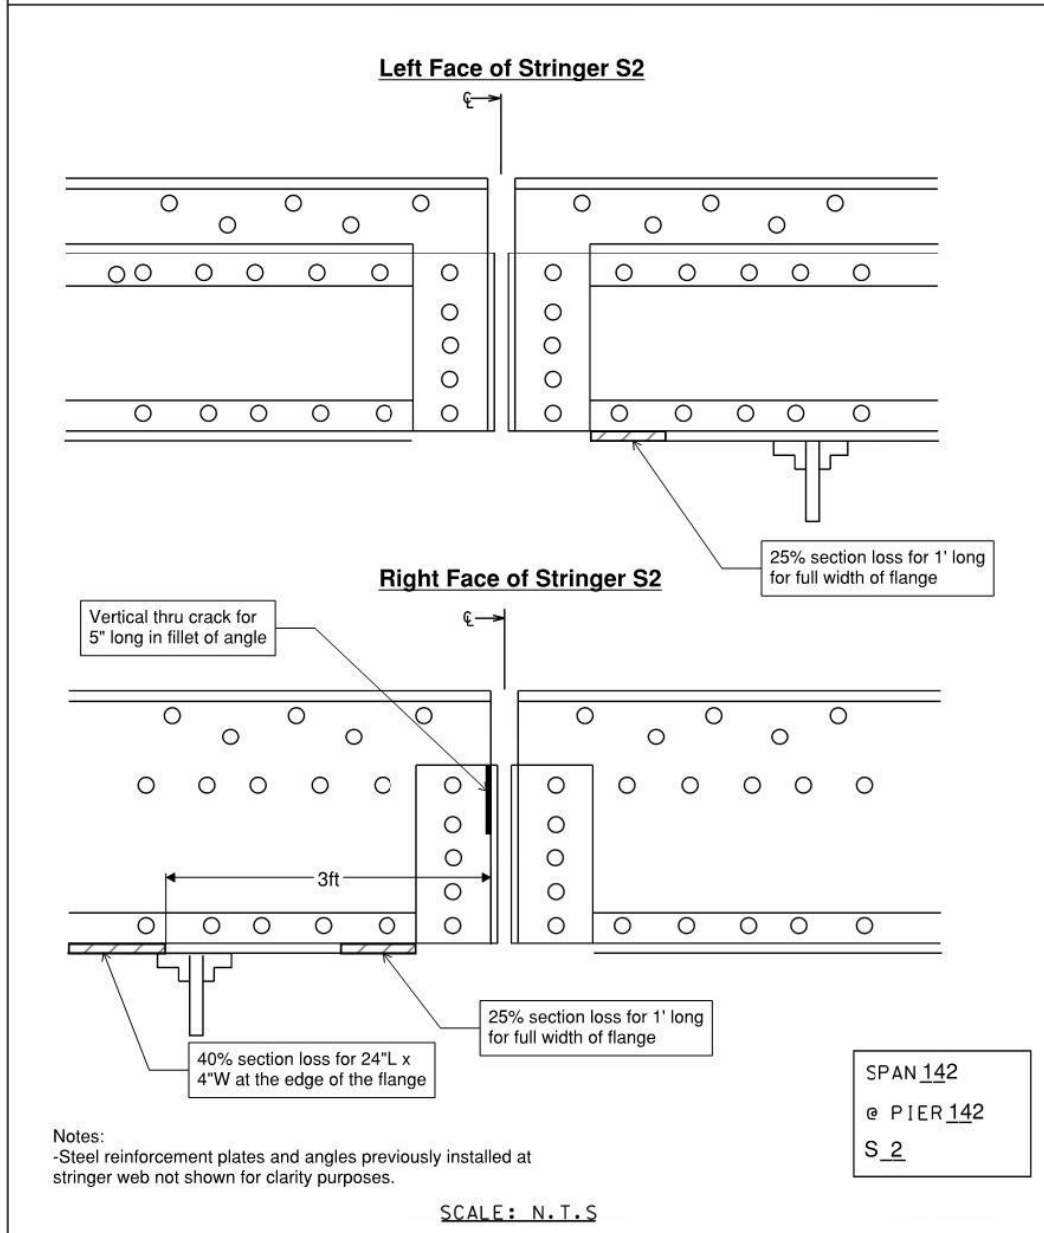
Photo Number: 2

Attachment Description: Yellow Flag Condition Sketch

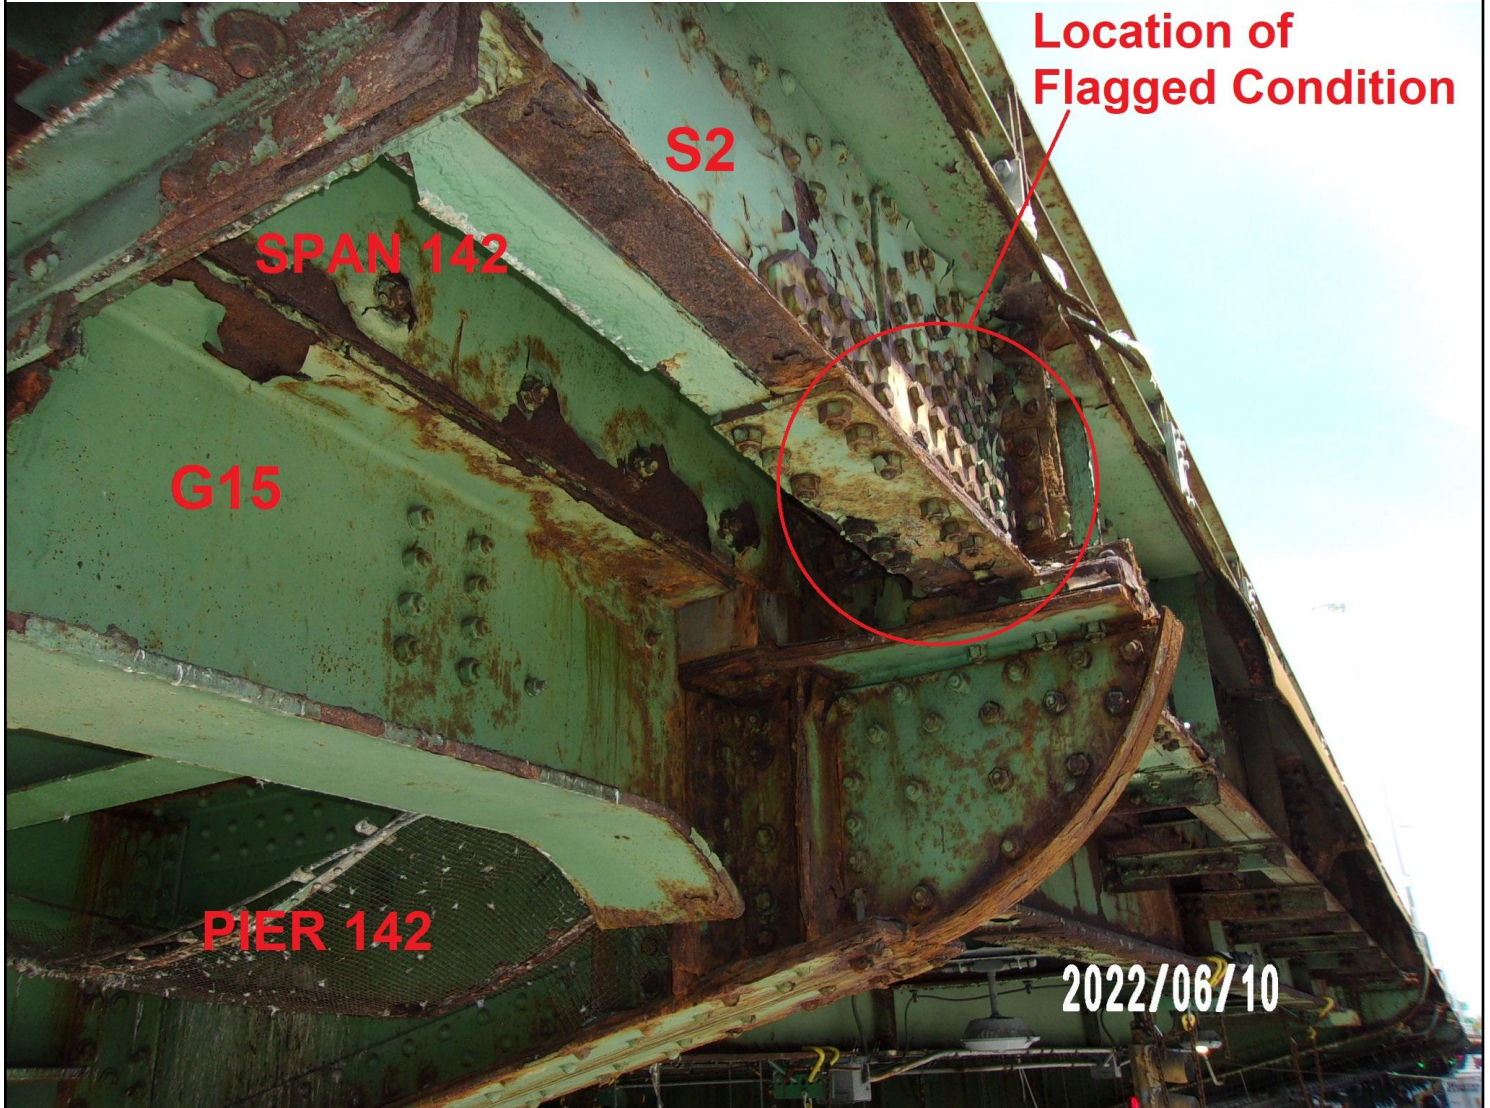
Photo Number: 3

Attachment Description: General view of Stringer S2 in Span 142 at Pier 142. Looking End and Left.

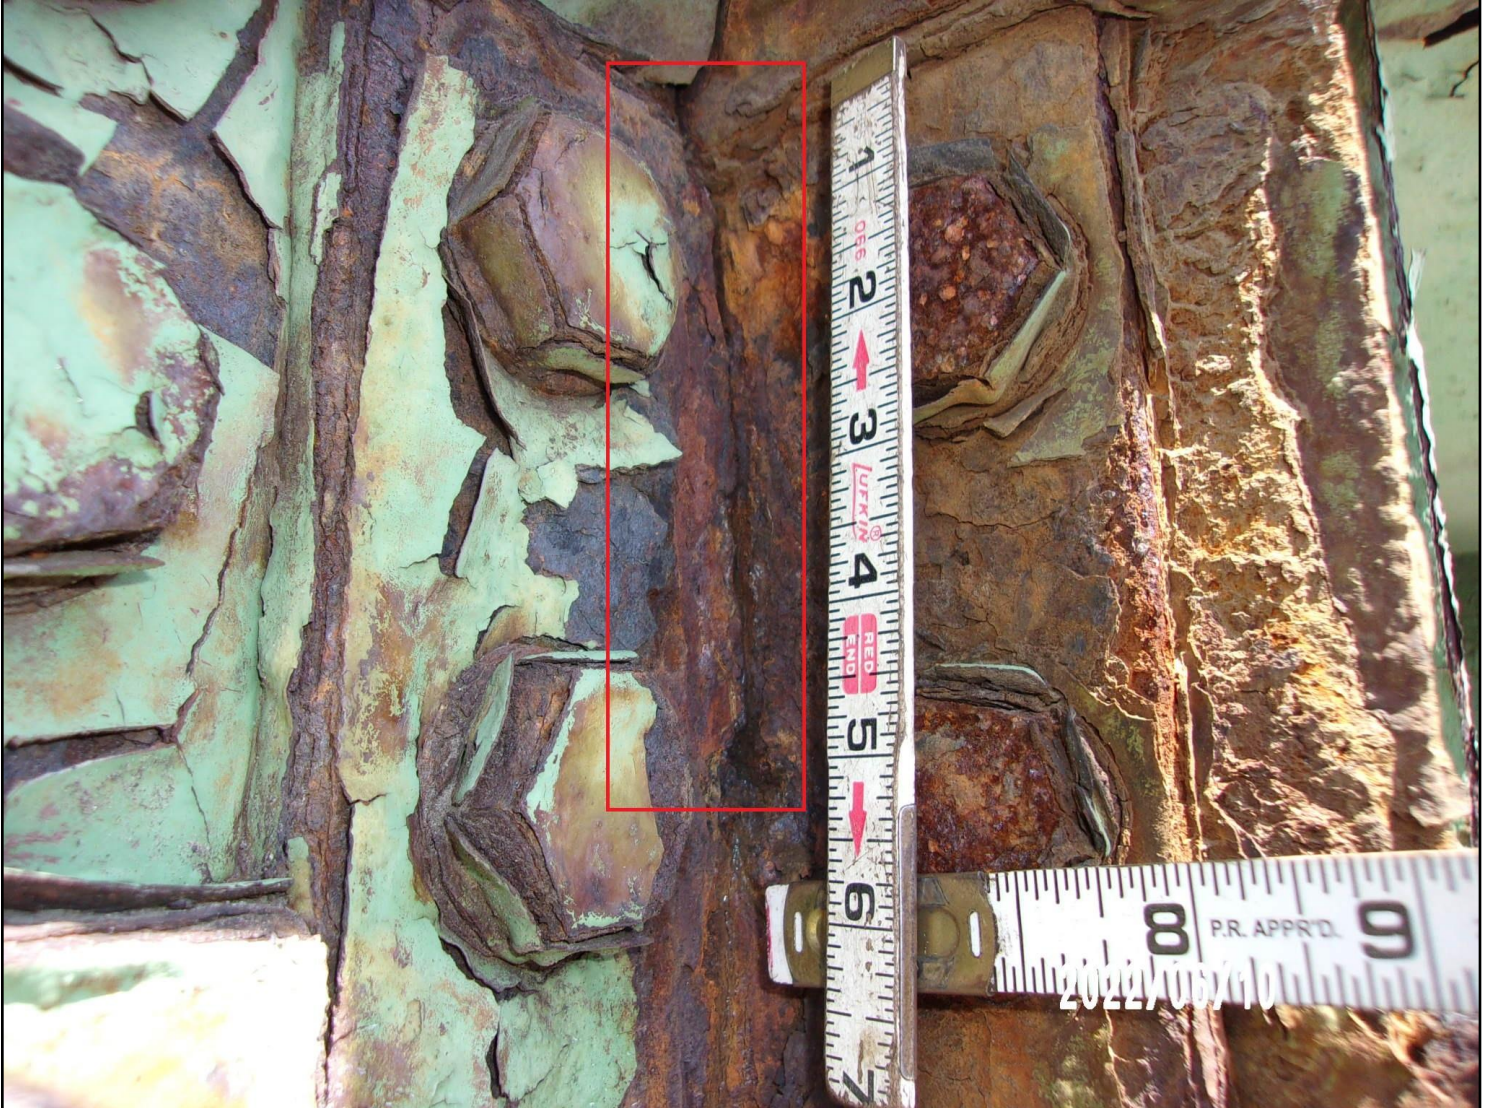
Photo Number: 4

Description: The end of Stringer S2 on Span 142 side of Pier 142 exhibits a vertical crack in the fillet of the right connection angle for 5" long starting at the top of the angle at the face of the stringer (Photo 4). The bottom flange of the stringer exhibits 25% section loss for the full width of the flange for 1' long adjacent to the bearing (Photo 6). The right side of the bottom flange exhibits 40% section loss for 24"L x 4"W at the edge of the flange starting at approximately 3ft from the stringer end. The stringer web has previously installed steel reinforcement plates which exhibit no significant defects. The left connection angle at the stringer exhibits no significant defects. (Photo 5) The bearing plates below the stringer exhibit moderate corrosion.

Attachment Description: The right face of Stringer S2 in Span 142 at Pier 142. The right connection angle exhibits 5" long vertical crack along the fillet of the angle starting at the top of the angle. Looking End and Left.

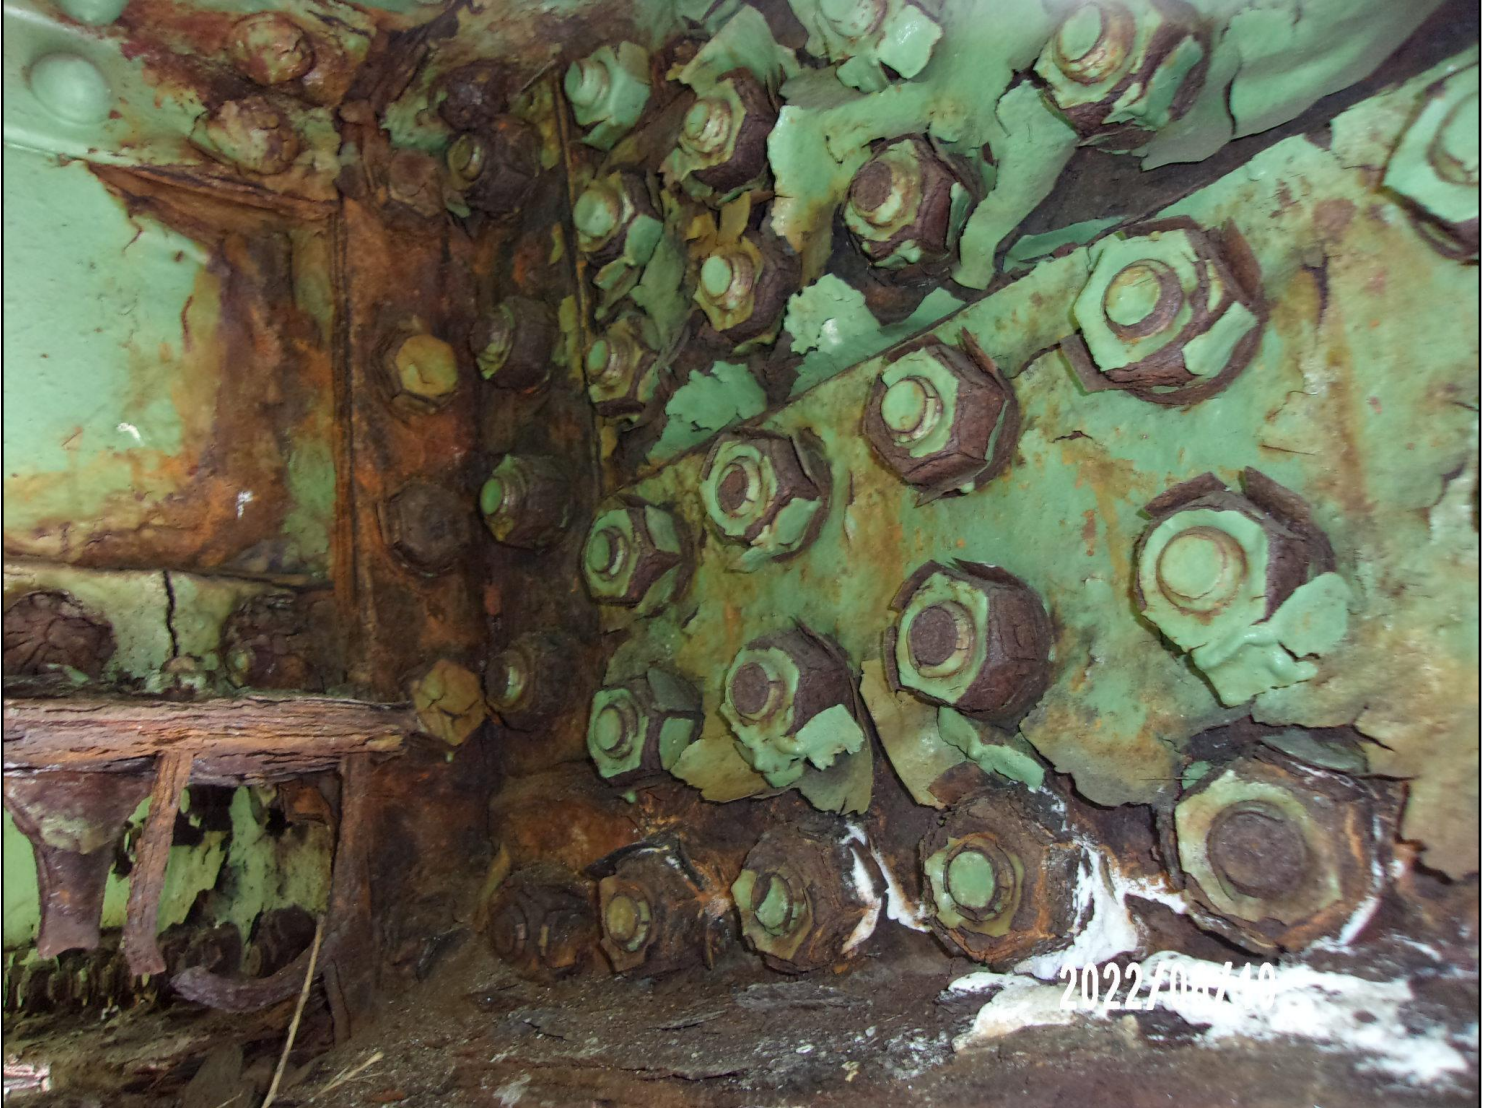
Photo Number: 5

Attachment Description: The left face of Stringer S2 in Span 142 at Pier 142. General view of the steel reinforcement plates and angles and left connection angle at the face of the stringer. Looking End and Right.

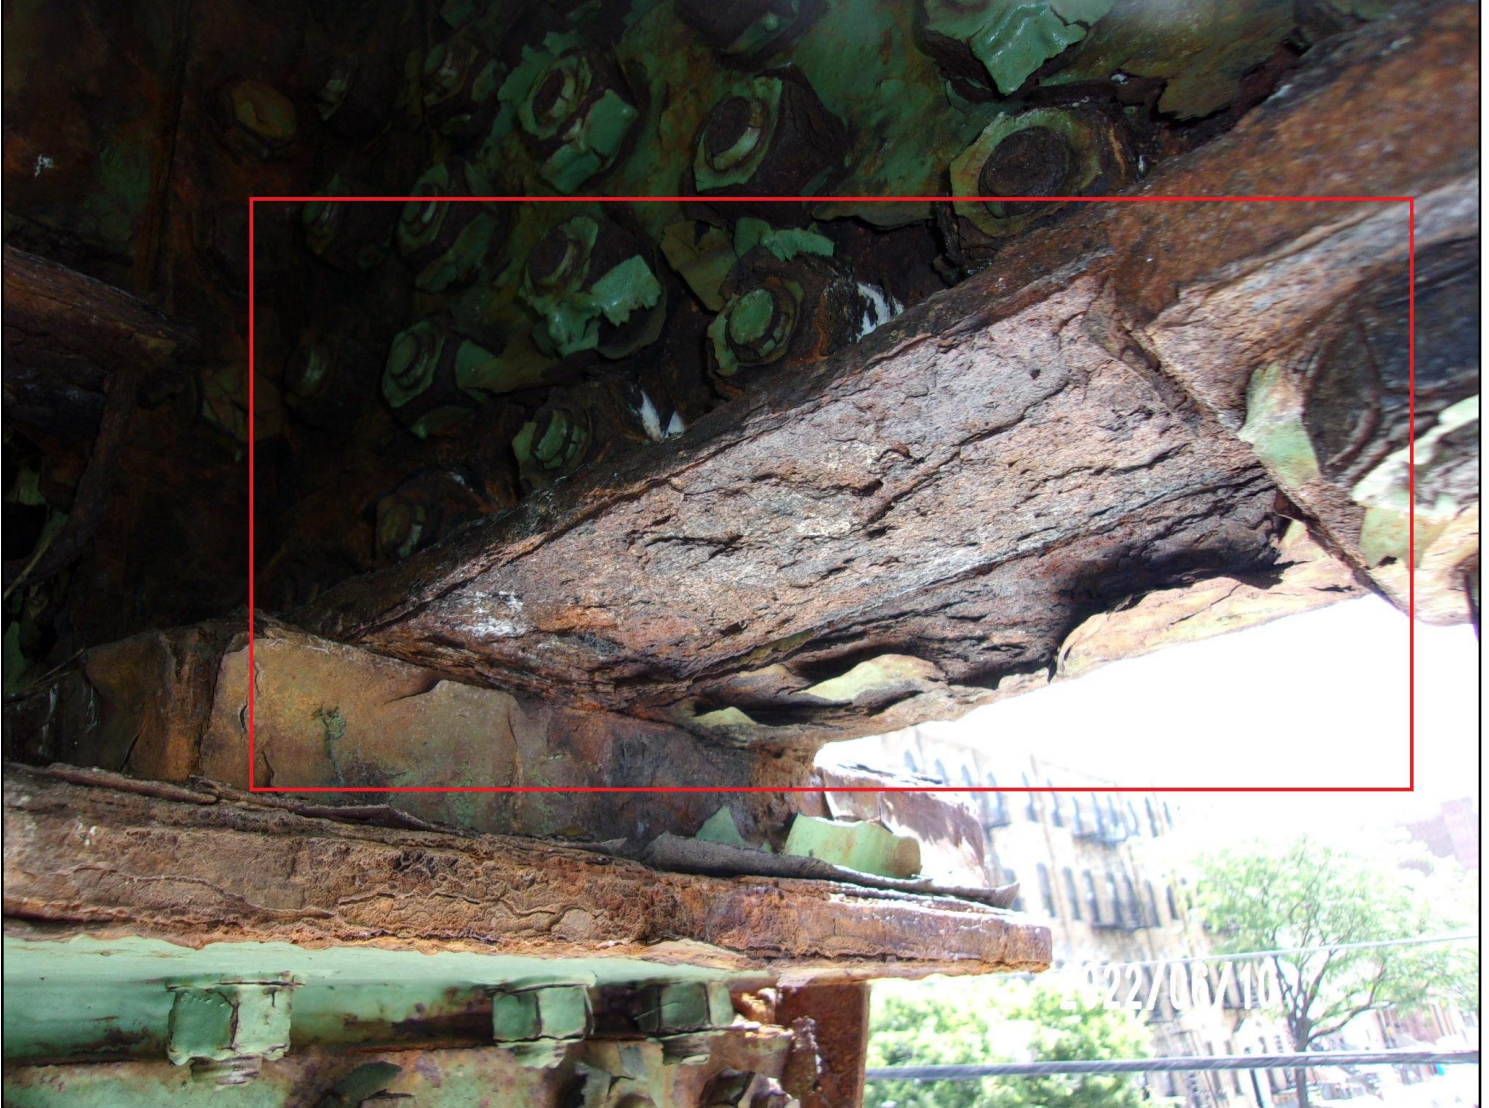
Photo Number: 6

Attachment Description: The bottom of Stringer S2 in Span 142 at Pier 142. The bottom flange exhibits 25% section loss for the full width of the flange adjacent to the bearing. Looking End and Right.
